*U.S. Army Corps of Engineers, Huntington District
Water Management Section
Water Quality Team*

Annual Water Quality Report

2019

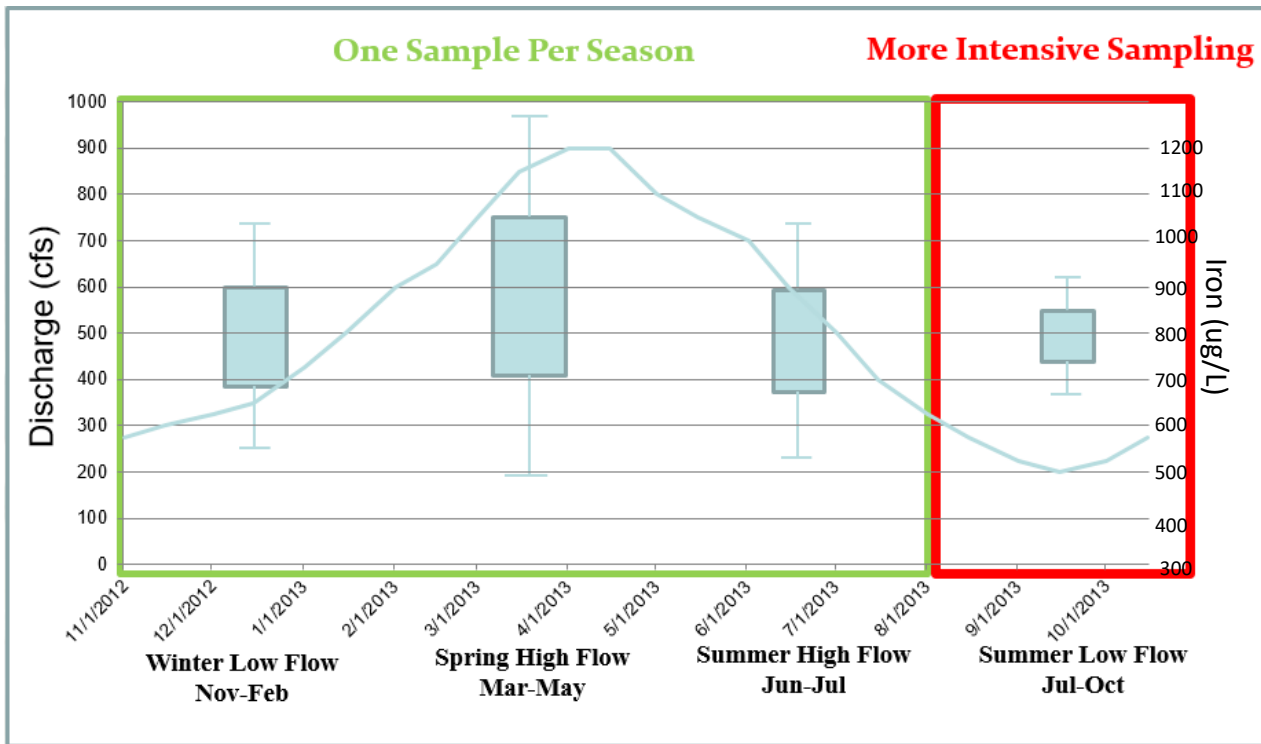
Figure 4. Demonstrates the flow and water quality variability that accompany different seasons of the year.

A seasonal approach has been implemented for intensive surveys in order to capture the natural variance in constituent levels that occurs during different flow periods ([Figure 4](#)). In regards to natural variance, the “Summer Low Flow” season (Jul-Oct) is the most stable flow period for both water volume and water quality. Consistent monthly sampling during this period allows the team to detect true water quality changes in the lake and watershed because the water chemistry is subject to fewer natural fluctuations. During other seasons, flows and water chemistry can be extremely variable, making it more difficult to determine true water quality trends or identify watershed disturbances. As a result, water chemistry sampling is less likely to detect smaller changes to a watershed, but we are able to bracket the range of “normal” conditions for those water bodies.

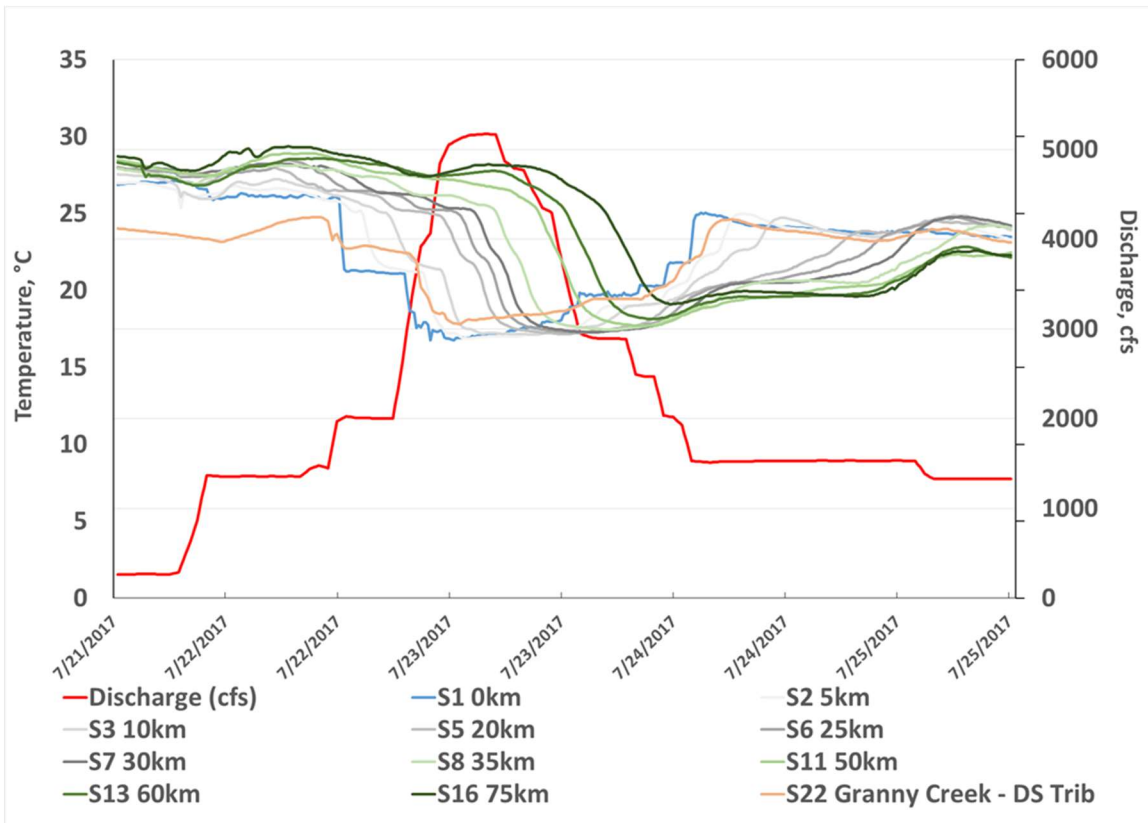
Figure 7. Temperature (°C) of the Sutton Lake outflow, the Elk River up to 75 km downstream of the outflow, and a downstream tributary (Granny Creek) compared to the lake discharge (cfs) in July 2017.

Temperature fluctuation downstream of the dam was minimal prior to the discharge event. Significant fluctuations are observed beginning around 12:00 on 7/23/17. As discharge volume increases, magnitude of temperature change from the previous hour increases as well. Magnitudes are greatest at the first monitoring site directly below the dam (S1) and generally decrease with distance from dam. Fluctuations in temperature appear to greatly diminish as discharge volume decreases and becomes more stable as time passes after the storm event.

As discussed in Table 3, magnitudes are greatest at the first monitoring site directly below the dam (S1) and generally decrease with distance from dam. Largest temperature fluctuations also occur later in the event as colder water makes its way downstream.

2018 Discharge Event: As compared to the 2017 event shown in figures 7 & 8, downstream temperatures in figure 10 are much more steady and consistent even though the discharge of the event is almost identical in 2018 (nearly 5,000cfs). Although these flow events occurred at different times of the year, the discharges followed similar trends. The 2017 event began with flow around 270 cfs and climbed to roughly 5,100 cfs over the course of 32 hours, while the 2018 event began with flow around 288 cfs and climbed to roughly 4,700 cfs over the course 11 hours. Due to these similarities, it is reasonable to compare the effects to temperature downstream. It is apparent upon comparing the events that the event in 2018 experienced much less fluctuation in temperature at all monitoring sites downstream. This can likely be partially attributed to better operation during storm events and may also be due in part to warmer temperatures at the bottom of the lake in comparison to the 2017 event. Profile data from the time of the event was unavailable so the next closest data was utilized for figure 9.

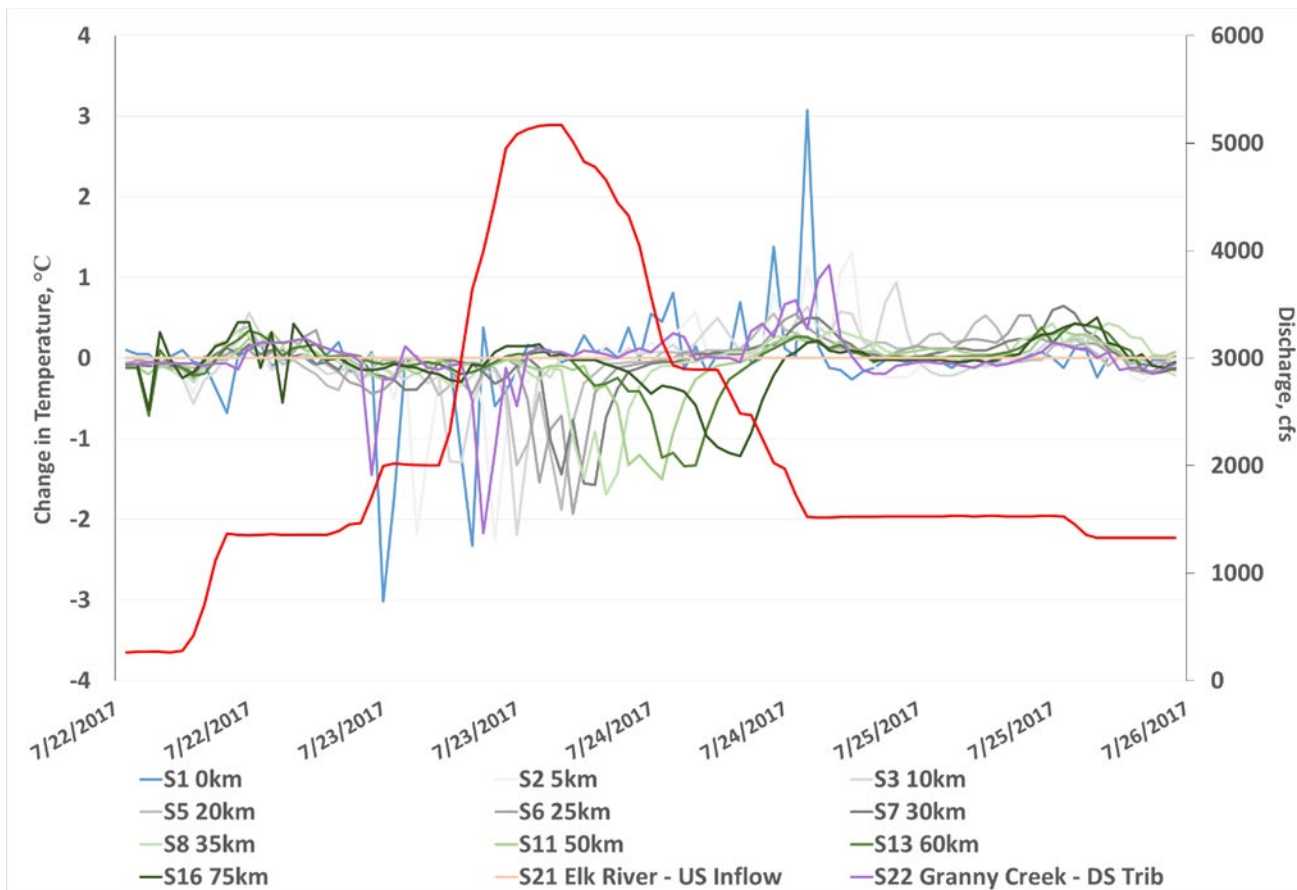
Figure 8. Change in temperature (°C) from previous hour of the Sutton Lake outflow, the Elk River up to 75 km downstream of the outflow, and a downstream tributary (Granny Creek) compared to the lake discharge (cfs) in July 2017.

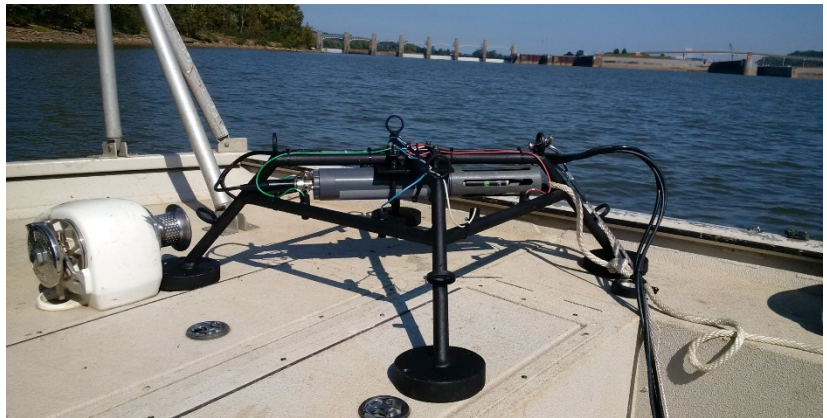
Figure 14. The WIZARD measures conditions in the actual substrate and the water column.

Turbidity, sedimentation, and dissolved oxygen levels are intensely monitored downstream of the dredge disposal area and adjacent to valuable mussel beds. Recently, the monitoring platform was upgraded to provide real-time data transmissions to the District in order to monitor the most current environmental conditions surrounding the mussel beds. No other USACE District has deployed such an innovative and advanced monitoring platform or operated for steering currents during dredging operations. These innovations have garnered praise from our partners in the state and federal resource agencies.

platform measuring sedimentation, dissolved oxygen, and turbidity. Due to the high water conditions, no WIZARDS were deployed in 2019. Flows were greater than 60,000 cfs during the entire summer dredge period. This required a minimum of 14 feet of gate opening. Flows were as high as 160,000 cfs requiring 107 feet of gate opening. Steering currents are not applicable in flows of this magnitude. In addition, these flows were high enough to minimize any impacts related to dredge disposal. Figure 16 shows the flow, stage, and dates of R.C. Byrd dredging. Dredging operations were stopped early as a result of the continuous high water.

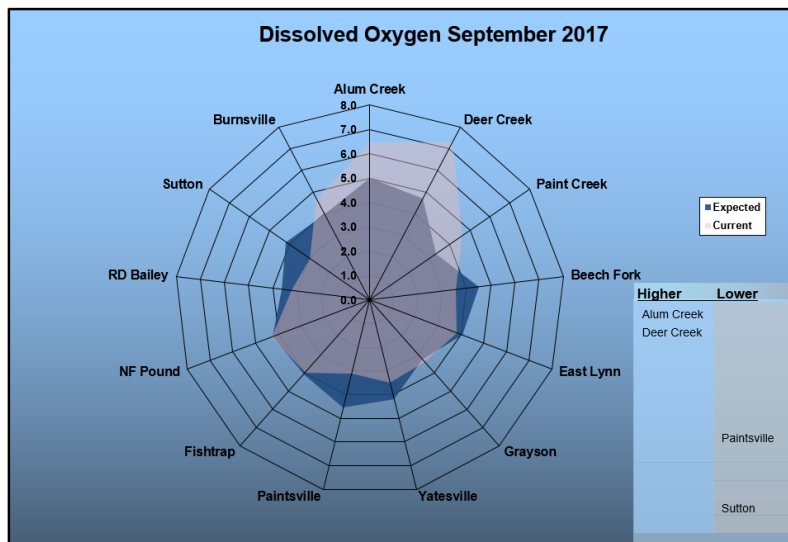
Figure 19. Average dissolved oxygen conditions at LRH Lakes in 2017. Average conditions for each lake are compared to what would normally be expected for the time of year. Dissolved oxygen levels were better than normal for most of the lakes.

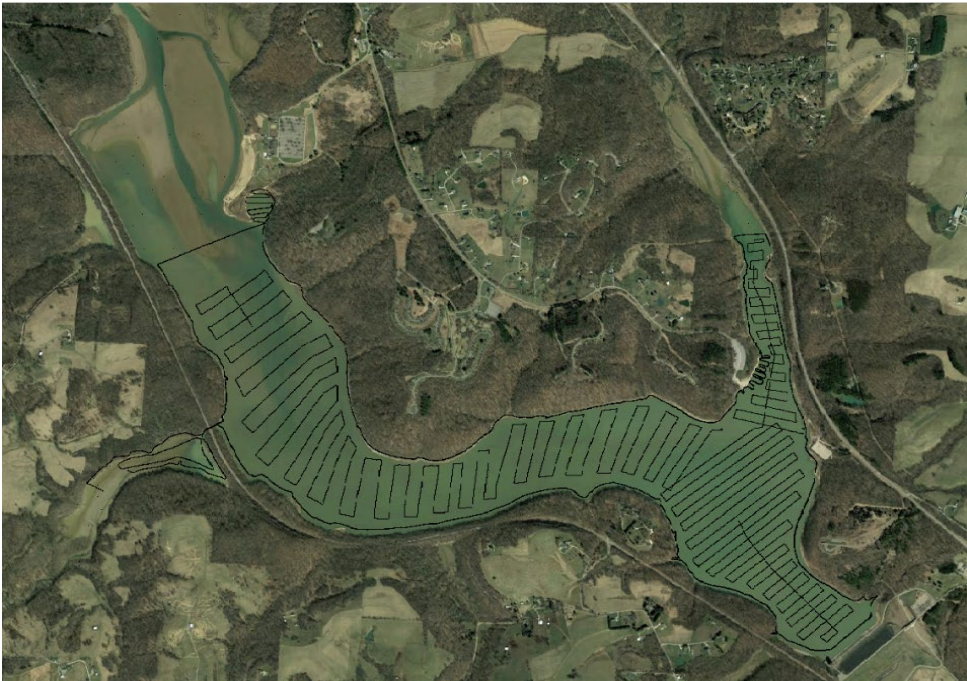
Figure 1. Bathymetry data collected using the EcoMapper and Acoustic Doppler Profiler.

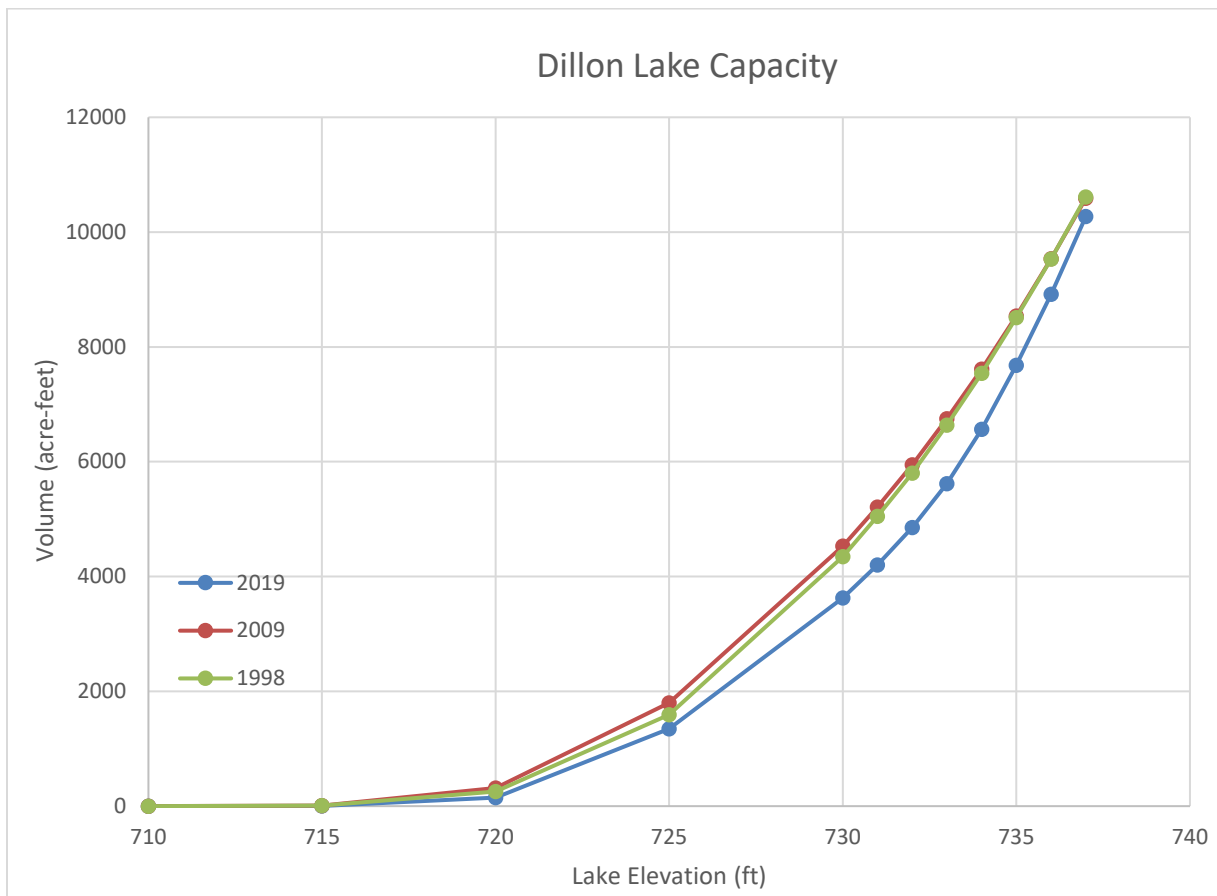
Figure 4. Updated storage capacity curves for Dillon Lake compared to previous surveys.
