*U.S. Army Corps of Engineers, Huntington District  
Water Management Section  
Water Quality Team*

# **Annual Water Quality Report 2021**

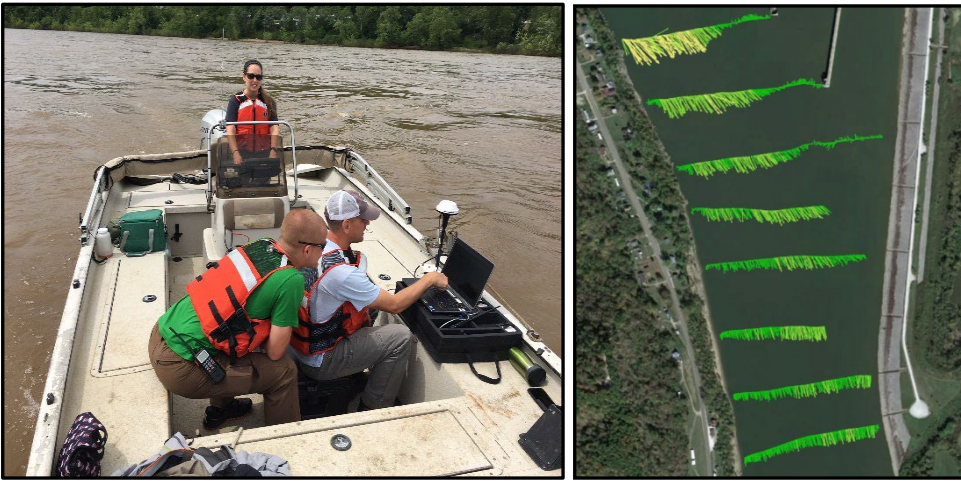
**Figure 8. Velocity vectors demonstrating the effectiveness of steering currents employed below R.C. Byrd Dam.**

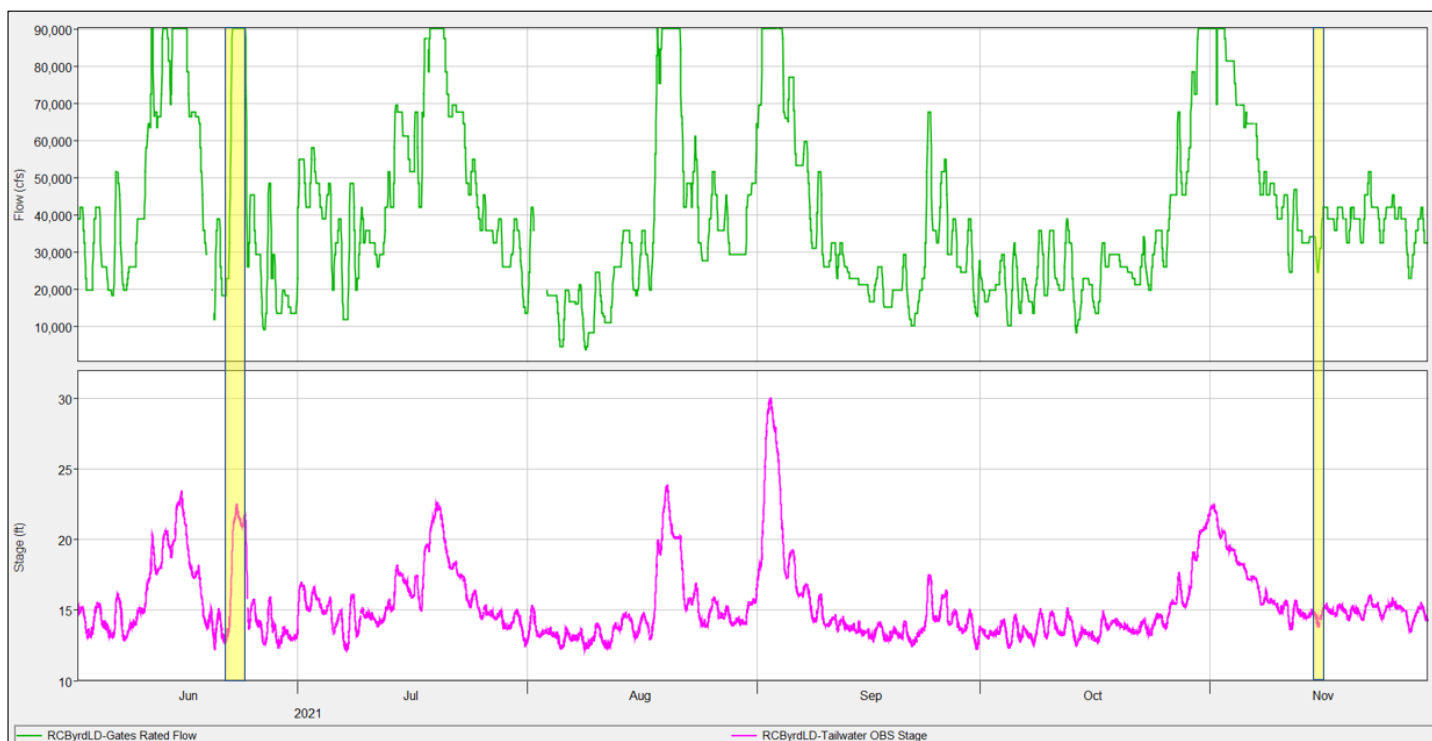
**Figure 10. Flows, stages and dredge dates (yellow boxes) for R.C. Byrd dredging in 2021.**

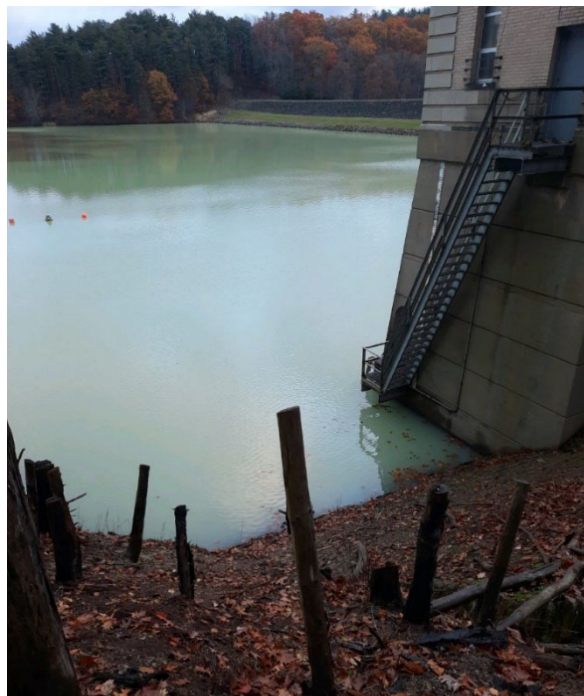
**Figure 14. White precipitate during a second turnover event at Clendening Lake in 2021.**

Water Management was notified of a potential HAB event at Clendening Lake on 15 November 2021. The water near the dam suddenly took on a cloudy green appearance which can be an indicator of a HAB. As seen in the photo ([Figure 14](#)), the Water Quality Team had a buoy transmitting lake conditions during the time of this event. After assessing the buoy data, the Water Quality Team determined that this change in surface water condition was the result of a second turnover event occurring late in the season. Initially, the lake had a turnover event on 15 October. After a period of warm, sunny and calm weather in November, the lake restratified. On the days preceding this second turnover event, the area was dominated by cold (10-15° F) and windy (20mph) weather which resulted in a quick remixing of the lake. This sudden remixing event caused an emergence of white precipitates (likely sulfur) on the surface of the lake creating the cloudy green appearance. During this time, dissolved oxygen at the surface went from 11mg/L to 2mg/L ([Figure 15](#)). Overall, impacts were likely minimal to the lake and aquatic habitats.

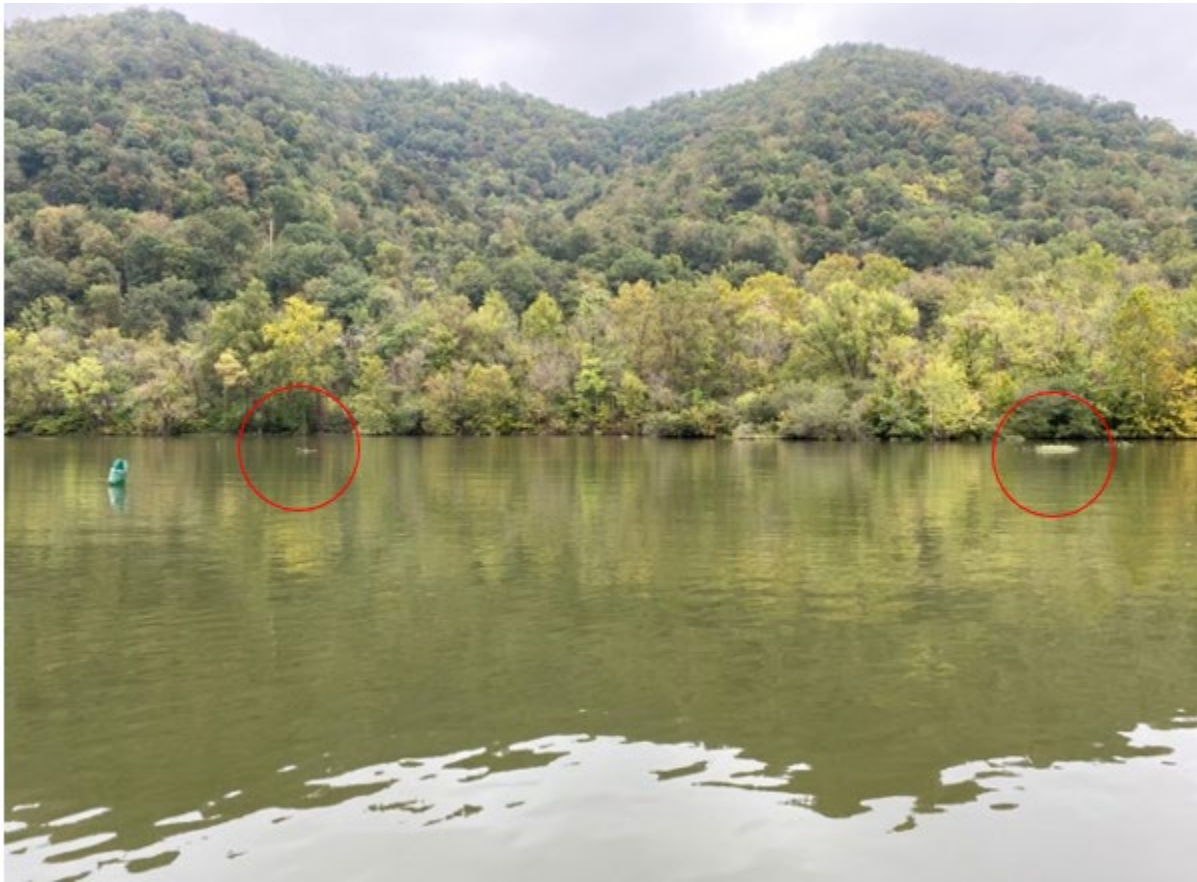
**Figure 16.** Small areas of emergent vegetation can be seen within in the Upper Approach of the London Locks & Dam. These pockets of vegetation suggest that a seed bed is established within the area that would be exposed if the navigation pool were dropped 2'.

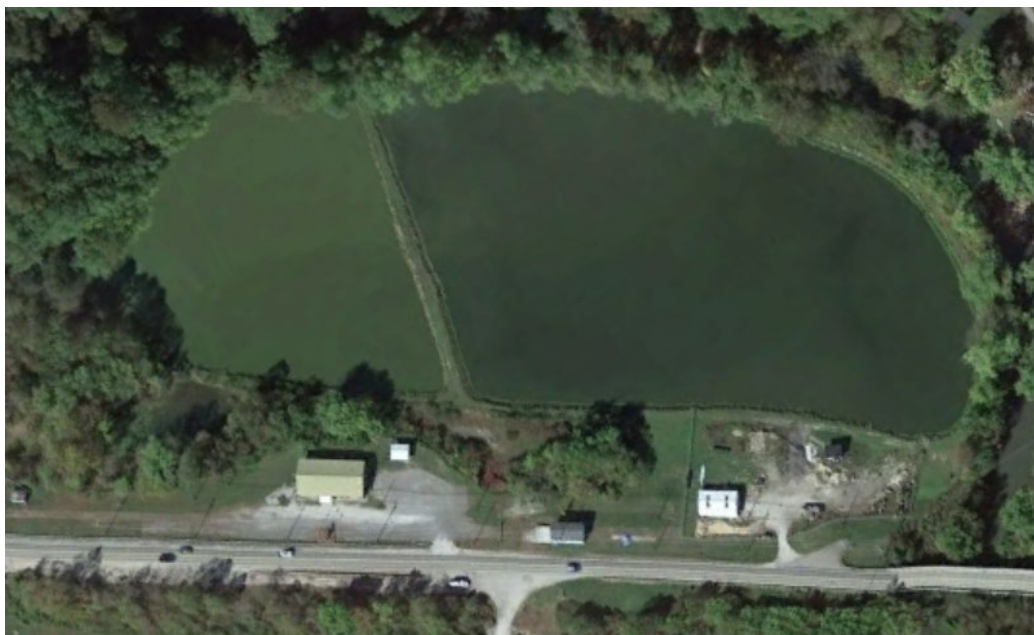
**Figure 18. Lagoon #1 is on the left with an average sludge depth of 15.7 inches. Lagoon #2 is on the right with an average sludge depth of 3.1 inches.**

Andrew Johnson spoke with Robert Gates of the WV DEP regarding the results and sludge disposal procedures. Robert confirmed that a plan will need to be developed and approved for disposal of the sludge from Lagoon #1.

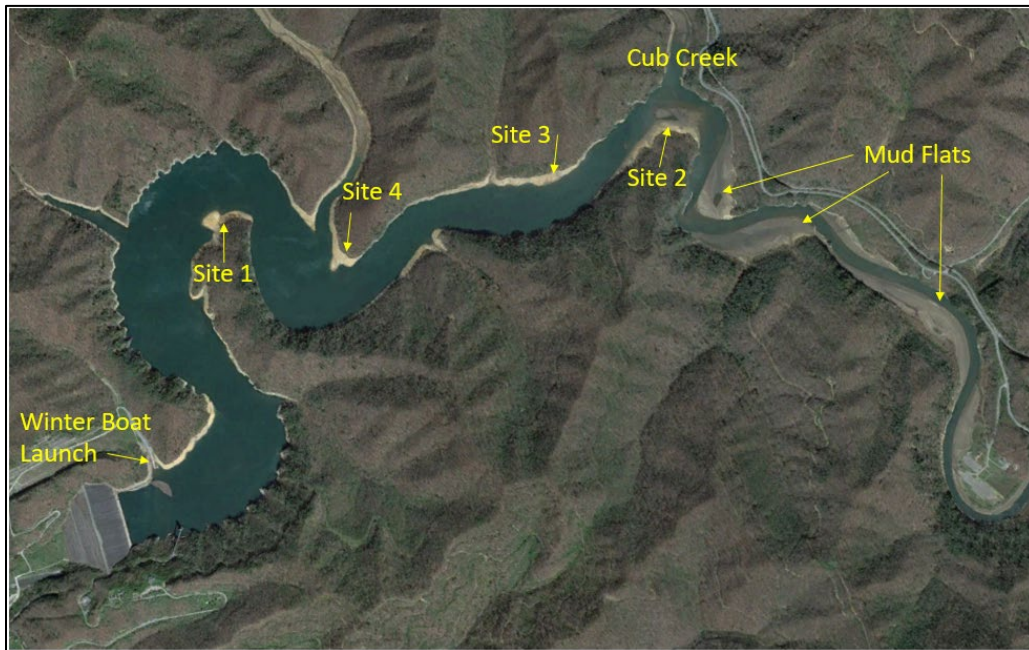
Figure 21. Mussel survey areas during a deep drawdown operation in 2018.

A similar survey event took place during a deep drawdown in 2018. At that time, staff assessed four areas of shoreline on RD Bailey Lake between the dam and Big Cub Creek (Figure 21). A total of 6.5 man hours was spent searching the banks for mussels and shell material. Staff assessed elevations between summer pool and winter pool, but additional effort was concentrated along the areas adjacent to the winter pool elevation. The only native mussel species that was encountered was *Utterbackia imbecillis* (paper pondshell). No *Utterbackia* were found near water's edge. All fresh dead mussels had perished as a direct result of the drawdown from summer to winter pool. Many weathered shells of *Corbicula* were also found along the banks.

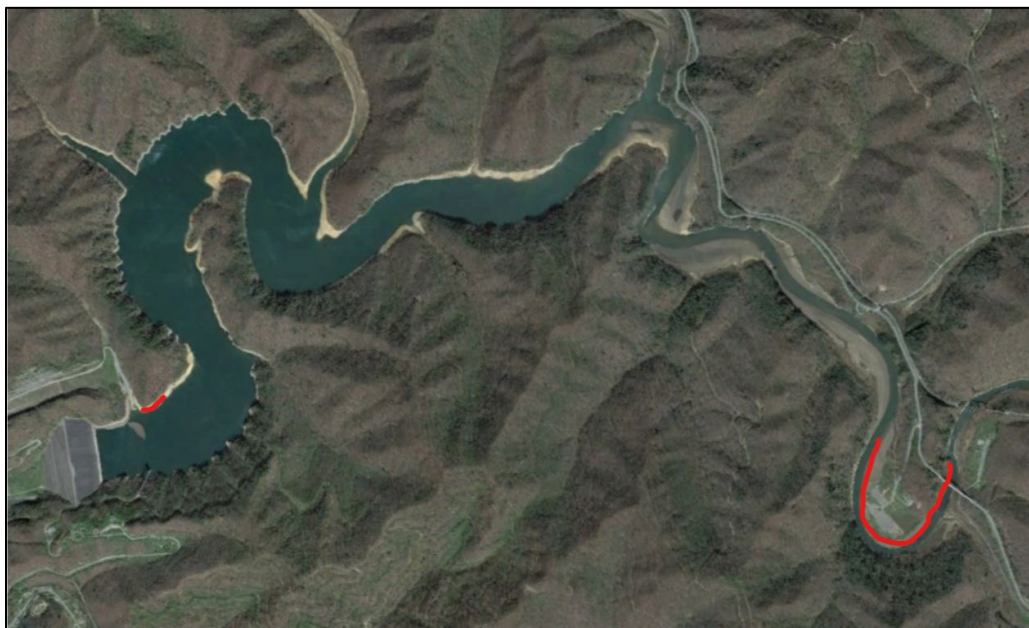
Figure 22. Mussel survey areas (highlighted in red) during a deep drawdown operation in 2021.

During this recent assessment (approximately 4 man hours), Water Quality staff searched more of the headwaters of the lake because the main lake lacked any significant mussel resources in 2018. This survey took place while the lake was at elevation 995' (Figure 22) near the Day Use Area boat ramp. These areas were nearly devoid of sandy and rocky areas because of the inundation of silts and mud. We also assessed a smaller area near the Winter Boat Launch where sands and gravels were more common, but the banks were very steep. As in 2018, no significant mussel resources were located. Less than 20 individuals (fresh dead) were found consisting of two species of native mussels, *Utterbackia imbecillis* and *Leptodea fragilis*. One weathered dead *Potamilus alatus* was also found. Also consistent with 2018, the fresh dead were in areas that were exposed during the normal winter drawdown from elevation 1035' to 1012'. Most specimen looked to be young-of-year individuals.

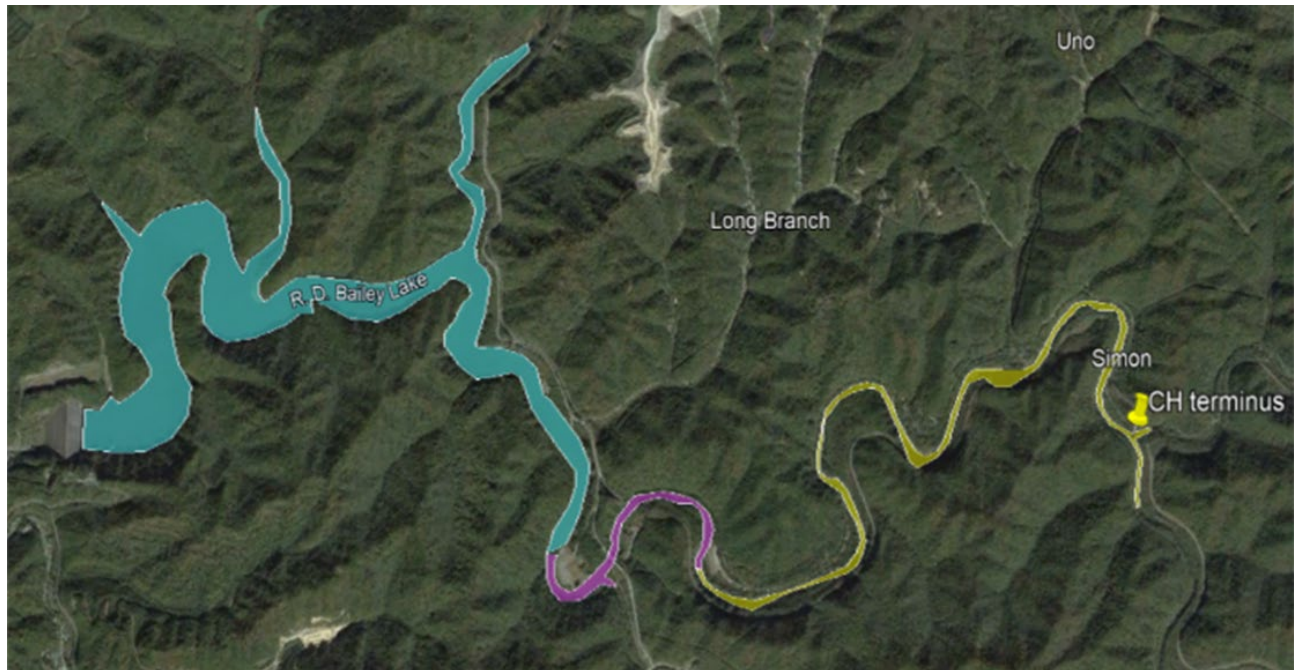
**Figure 23.** Map of R.D. Bailey Lake and the 3 different reaches assessed during the November 2021 scheduled deep drawdown. The blue area represents the extent of normal winter pool at elevation 1012'. The purple area represents the extent of summer pool at elevation 1035'. The yellow area represents the normally free-flowing sections of the Guyandotte River that is frequently subject to floodwater inundation during flood control operations. The downstream terminus of proposed Critical Habitat for *C. veteranus* is labeled with a yellow pin.

For this assessment of *C. veteranus* habitat, approximately 2.4 miles of aquatic habitat were surveyed which included areas that are always impounded, areas that are impounded during both summer pool and flood control operations, and areas that are only impounded during flood control operations ([Figure 29](#)). The flood control lake has significant impacts to potential habitat within the summer and winter pool impoundment areas. These areas do not provide suitable habitat for *C. veteranus*. The areas upstream of the summer pool may provide habitat that is suitable to *C. veteranus* due to the presence of fast moving water and coarse, rocky habitat.

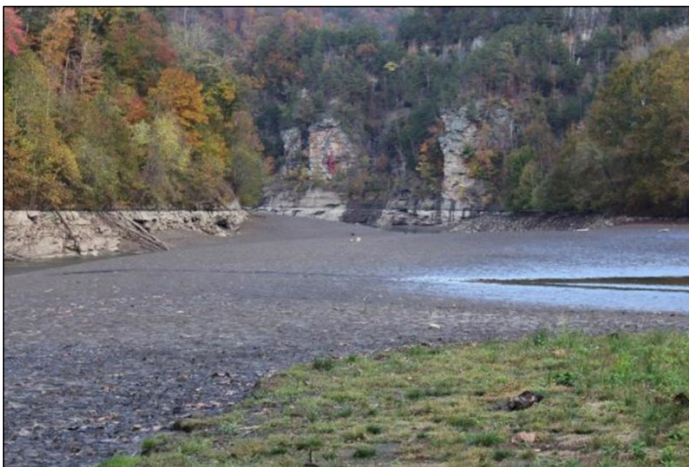
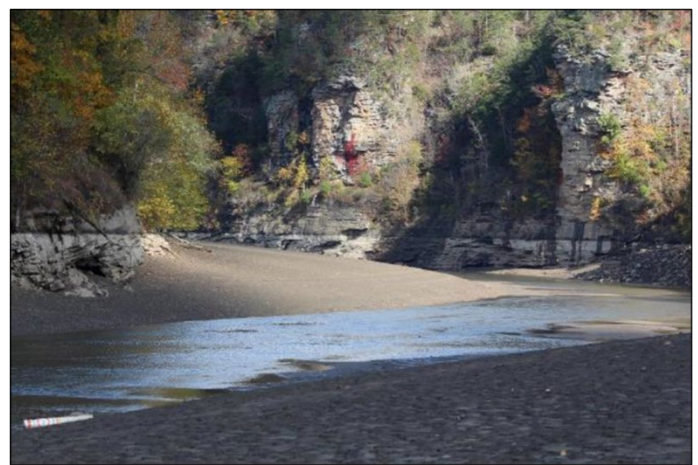
**Figure 24.** This is the section of the lake that is typically inundated during winter pool at 1012' but was exposed during the scheduled deep drawdown in November 2021 to 995'. This area is shown as blue on Figure 23.

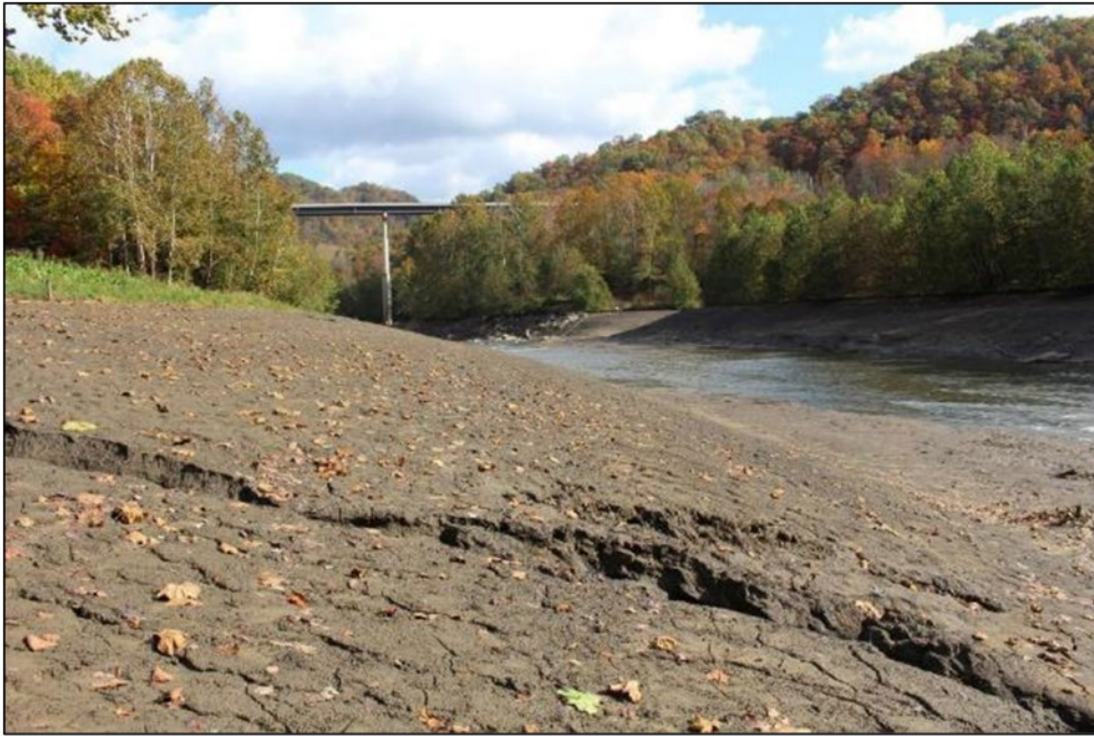
**Figure 25.** This is the section of the lake between the R.D. Bailey Lake Boat Launch and the Co Hwy 9/1 bridge. This section is inundated at the summer pool elevation of 1035' but is free-flowing during winter pool. This area is shown as purple on Figure 23.

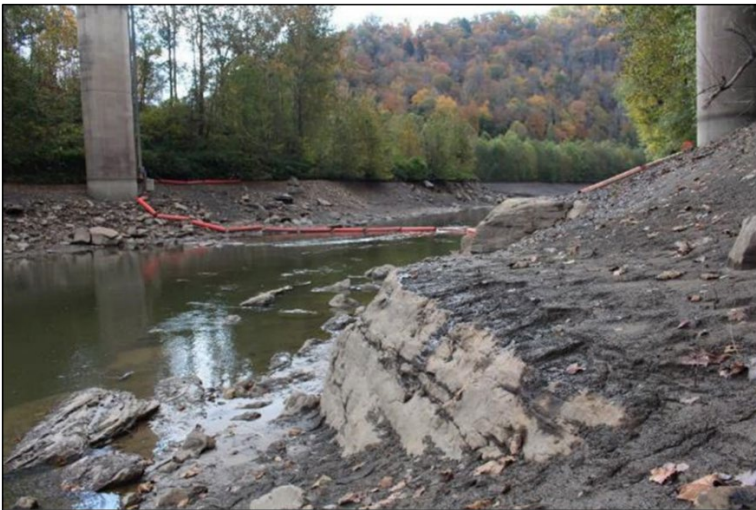
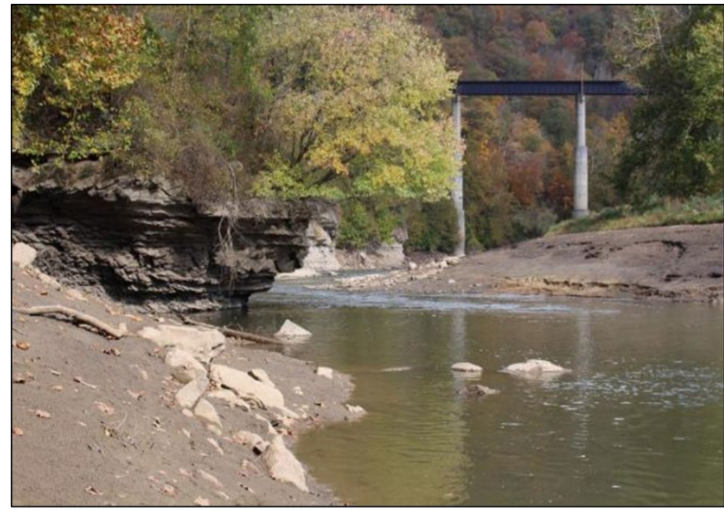
**Figure 26.** These photos show the lake area between the Route 9/1 Bridge and the railroad trestle. This section of the lake is shown as purple on Figure 23. These photos show the sedimentation of rocky habitat between normal winter pool elevation of 1012' and normal summer pool elevation of 1035'.

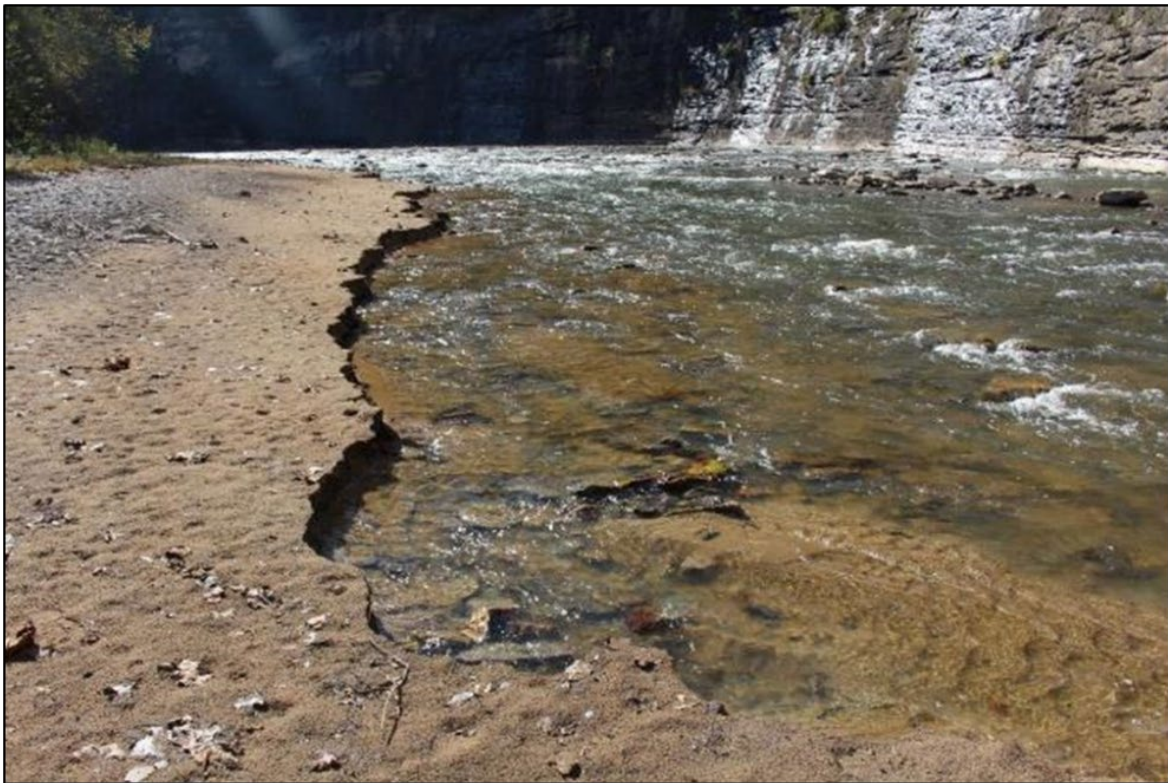
**Figure 27.** This photo shows the upper extent of normal summer pool near the unnamed boat launch at the end of Guyandotte Campground road. This area is likely subject to frequent deposition and scour cycles. This area is shown as purple in Figure 23.

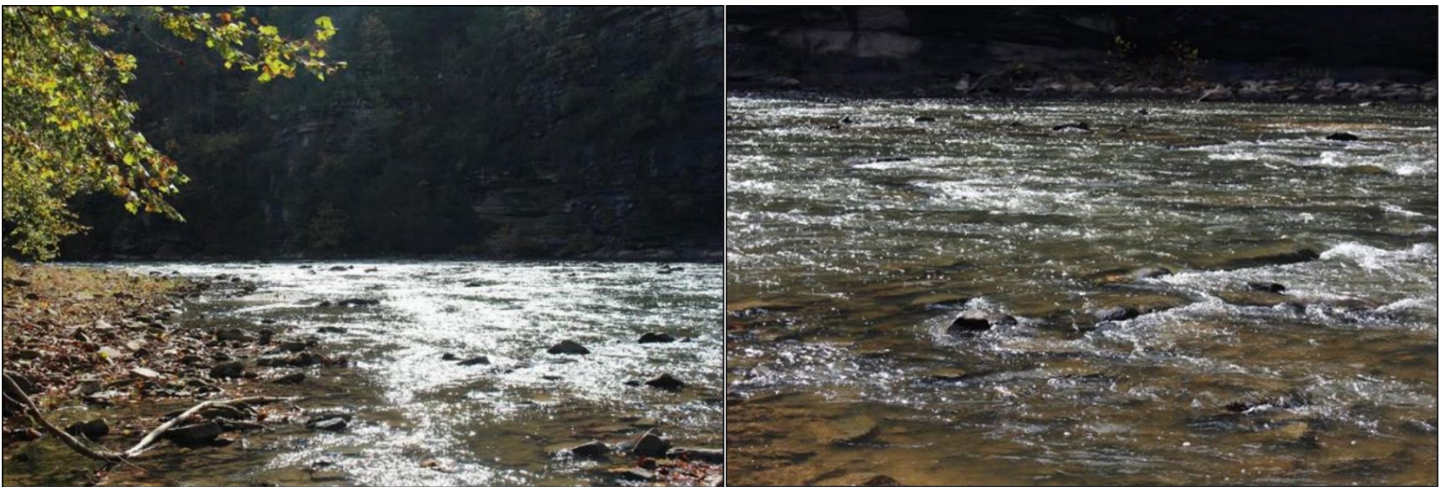
**Figure 28.** Near the campground boat ramp is the free-flowing section of the Guyandotte River just upstream of the normal summer pool. This section is not impacted by summer pool but is subject to inundations from flood control operations. This area is shown as yellow in Figure 23.

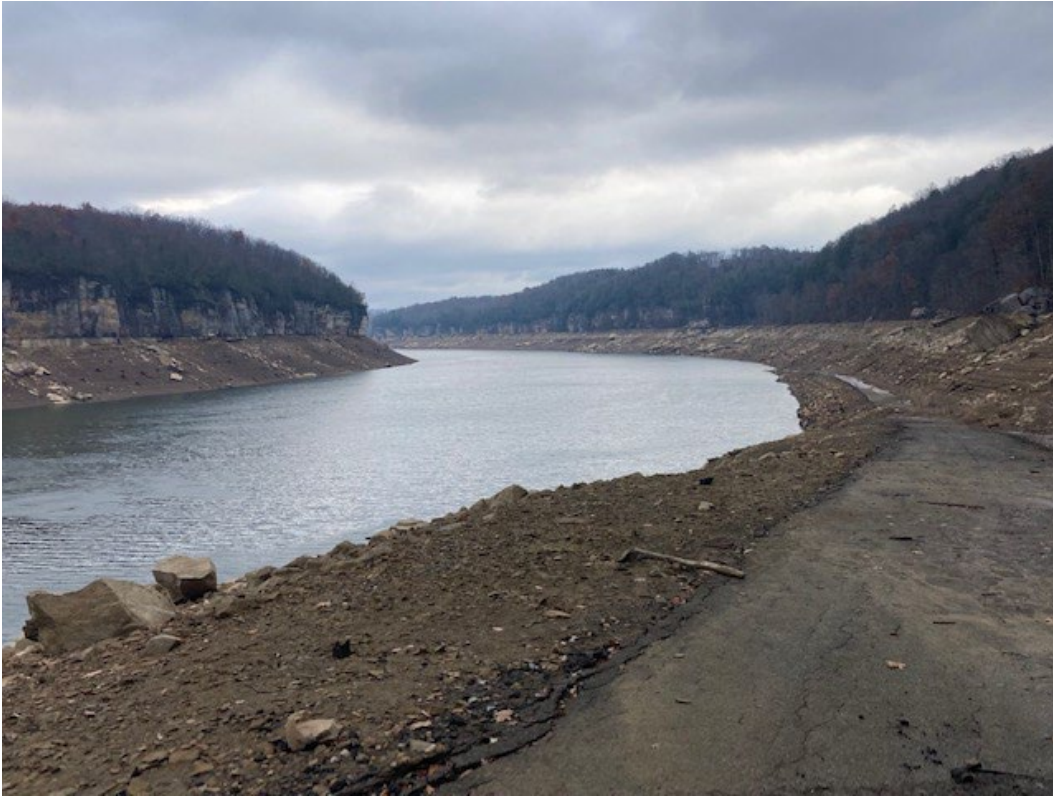
**Figure 30. Steep banks are exposed during normal drawdowns at Summersville Lake.**

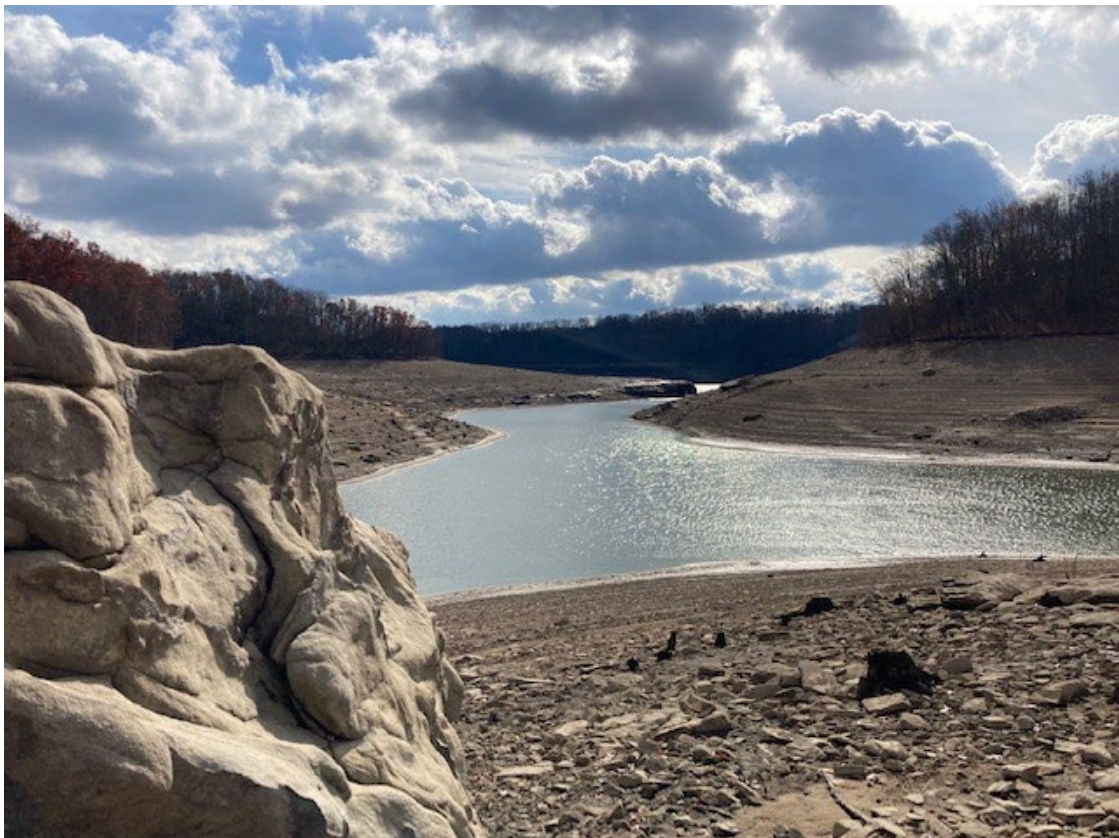
**Figure 31. Shoreline habitats are dominated by steep slopes with loose sand, gravels, and cobbles.**

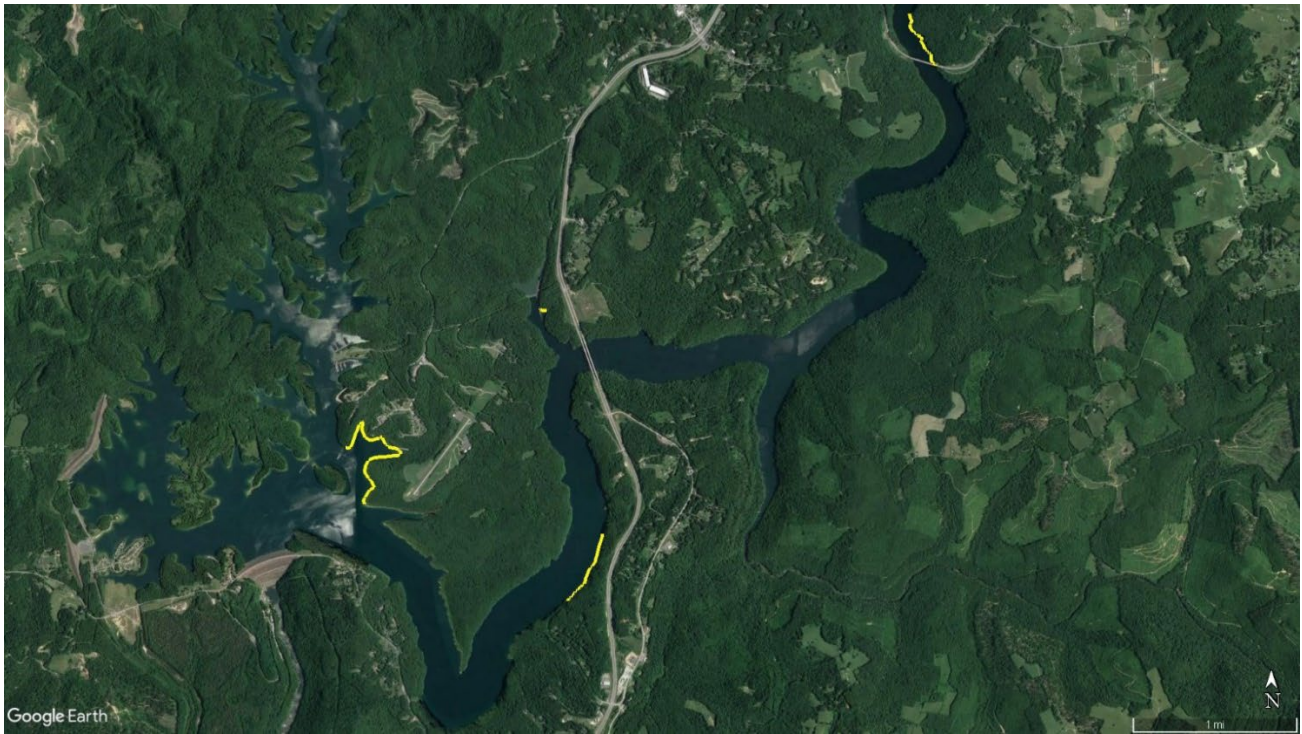
**Figure 32. Summersville Lake mussel assessment areas are shown in yellow.**

Four sites were assessed for mussel resources ([Figure 32](#)). Three of these sites were still impounded and in the area of the lake that would be impacted by the deep drawdown. Two of these impounded sites were within the main lake area while the third was located up a small tributary at the base of Salmon Run boat ramp. The fourth site was located just upstream of the winter pool limits on the mainstem of the Gauley River where the habitat was dominated by swift, riverine conditions. Approximately 2 miles of banks were assessed between the summer pool and winter pool elevations along the shoreline. Not a single native mussel shell was located in these areas. One fresh dead Asiatic clam was found along with one weathered shell.

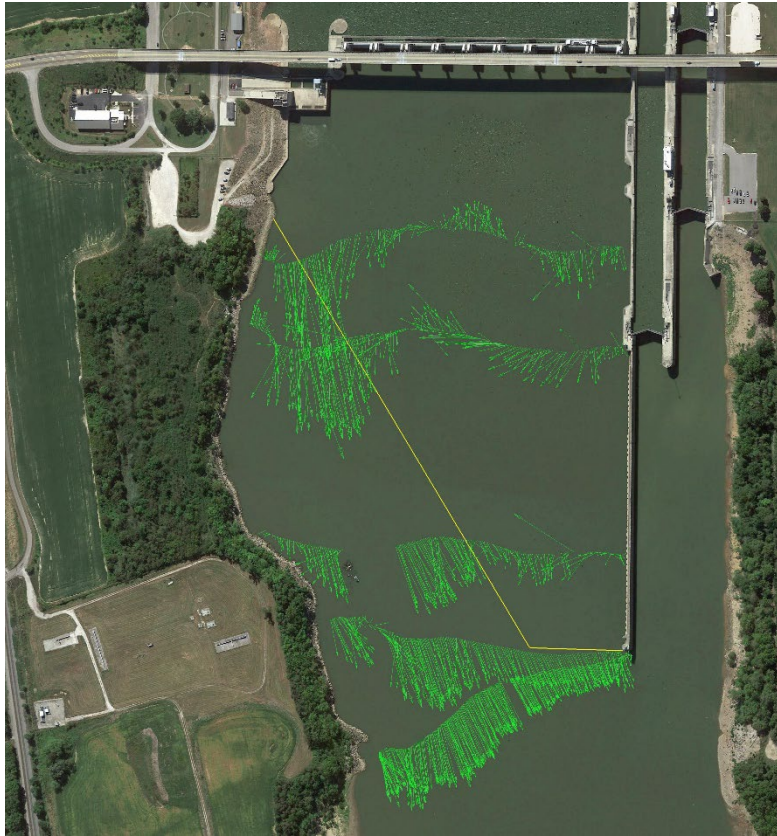
**Figure 33. Results from the velocity vector survey below Greenup Dam. The yellow line delineates the restricted zone.**

In November 2021, the Water Quality Team and Operations conducted a river velocity survey below Greenup Dam using a Sontek M9 Acoustic Doppler. This data was requested due to congressional inquiry and to determine if the current restricted zone was appropriate for safety concerns. Velocity vectors were generated for five transects within and outside of the restricted zone ([Figure 33](#)). In several areas the direction of the flow changes drastically creating eddies which could be hazardous to recreational boaters. This data was provided to the Ohio-Kanawha Locks Ranger to determine if the current restricted zone is appropriate to address boater safety concerns.

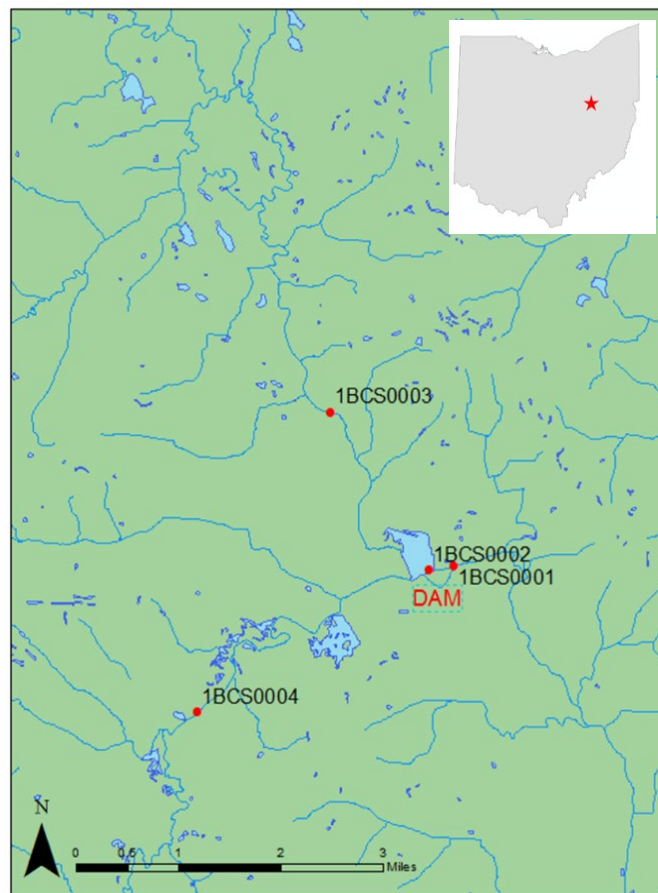
Figure 36. Water quality sampling locations for Beach City Lake in 2017.
