*U.S. Army Corps of Engineers, Huntington District  
Water Management Section  
Water Quality Team*

# **Annual Water Quality Report 2023**

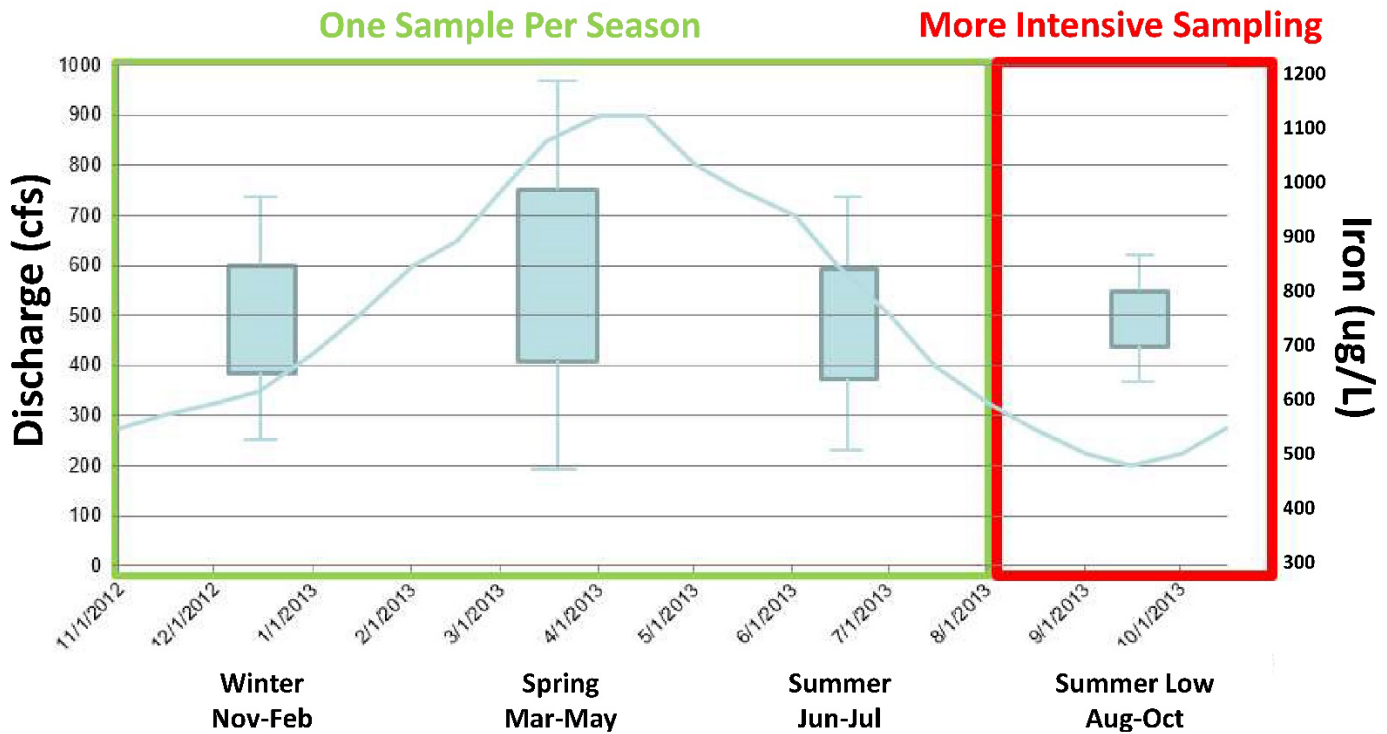
Figure 4. Demonstrates the flow and water quality variability that accompany different seasons of the year.

A seasonal approach has been implemented for intensive surveys to capture the natural variance in constituent levels that occurs during different flow periods ([Figure 4](#)). The “Summer Intermediate-Low Flow” season (Jun-Oct) is the most stable flow period for both water volume and water quality. Consistent monthly sampling during this period allows the team to detect true water quality changes in the lake and watershed because the water chemistry is subject to fewer natural fluctuations. During other seasons, flows and water chemistry can be extremely variable, making it more difficult to determine true water quality trends or identify watershed disturbances. As a result, water chemistry sampling is less likely to detect smaller changes to a watershed but can bracket the range of “normal” conditions for those water bodies.

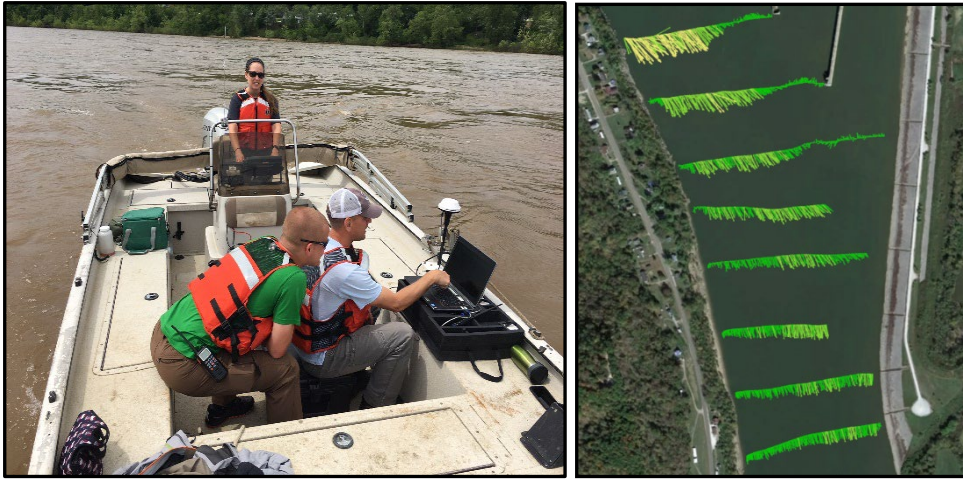
Figure 9. Velocity vectors demonstrating the effectiveness of steering currents employed below R.C. Byrd Dam.

dredge material disposal. The combination of mechanical dredge and steering current flows (Figure 9) allowed the dredging operations to continue without impact to the mussel beds. Figure 11 shows the flow, stages and dates of R.C. Byrd dredging. Figure 8 shows the WIZARD monitoring platform that monitors our mussel beds for impacts from dredge disposal. The WIZARD is a real-time platform measuring sedimentation, dissolved oxygen, and turbidity. The WIZARD was deployed in August once dredging began and remained in the water for further analysis. Data showed that there was likely no accumulation of sediments over the mussel beds as a result of dredge operations. The WIZARD continues to show interference from daily temperature swings. This issue produces false diurnal swings in the data. These swings can be edited out by showing the transducer results using a running 24-hour average (Figure 10). As a result of this monitoring, good flow and stage levels, and steering currents, no changes were required during dredging operations at R.C. Byrd in 2023.

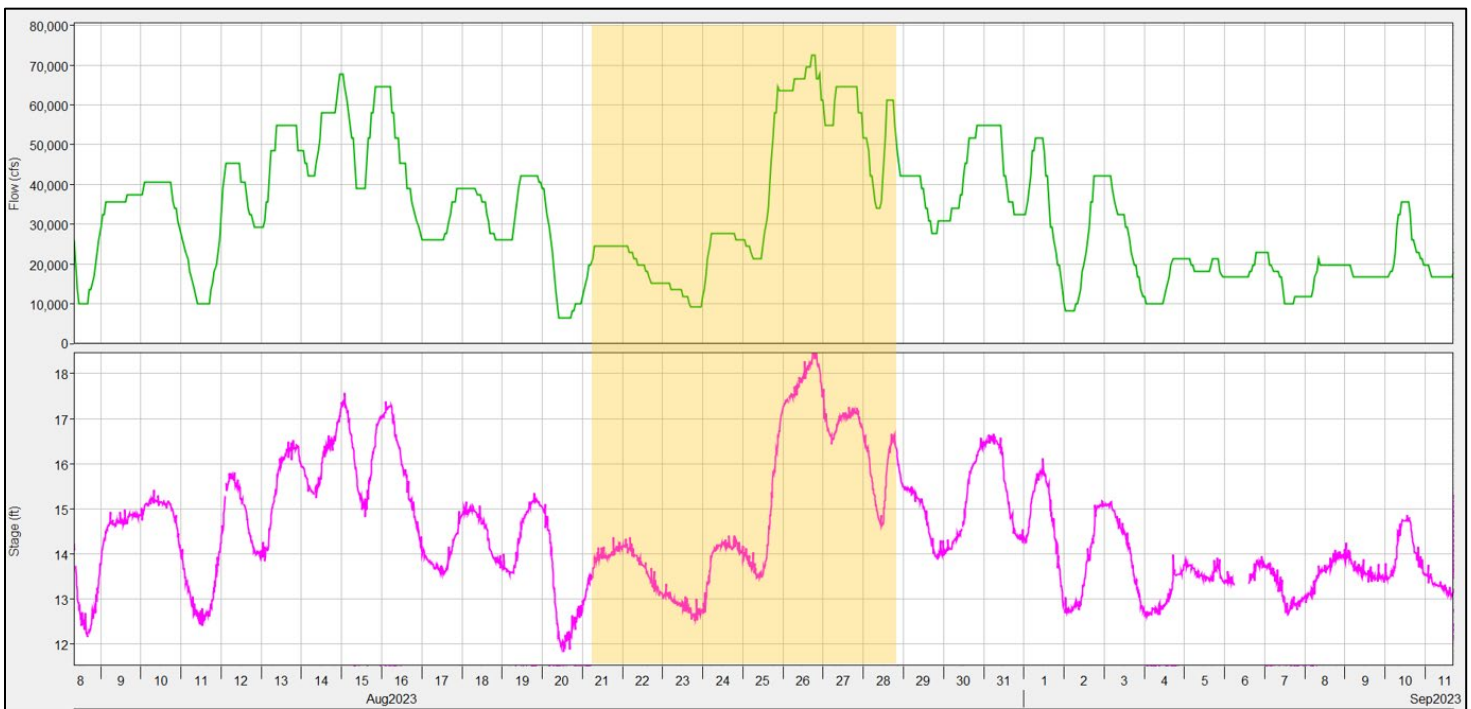
Figure 11. Flows, stages, and dredge dates (yellow box) for R.C. Byrd dredging in 2023.

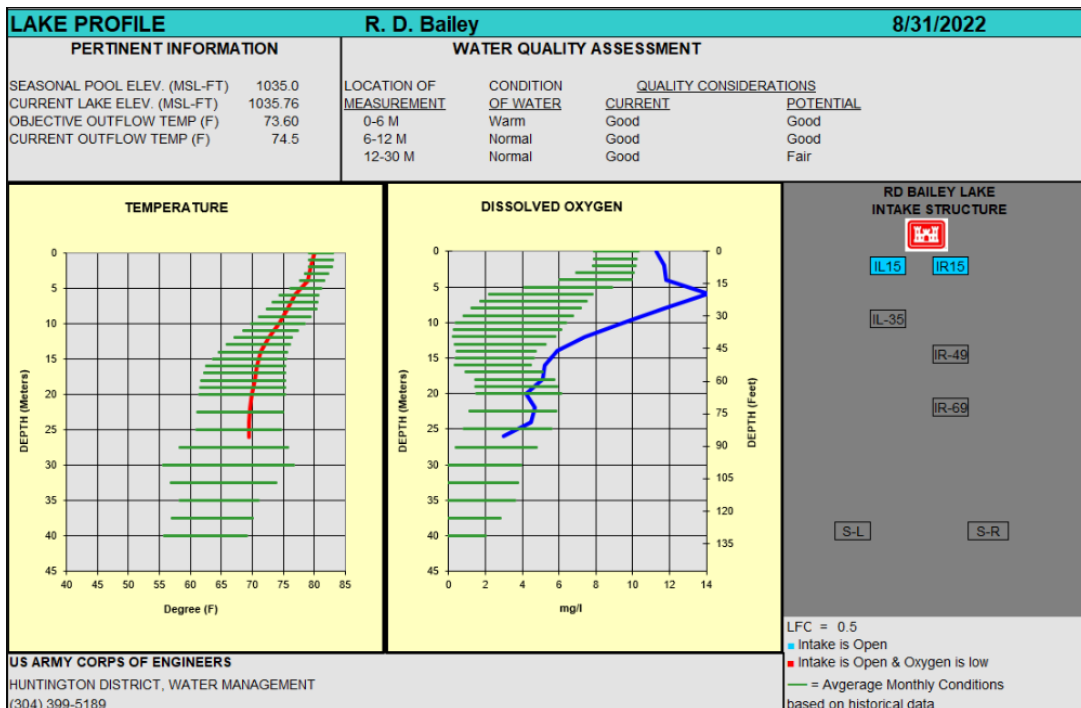
Figure 13. An example of the informational plots featured on the District Water Management public website. The plots are an output of the LRH lake profiling program.
